Wildfire Risk Assessment

Kensington Park Structures

Kensington, California

Report Date: May 18, 2026

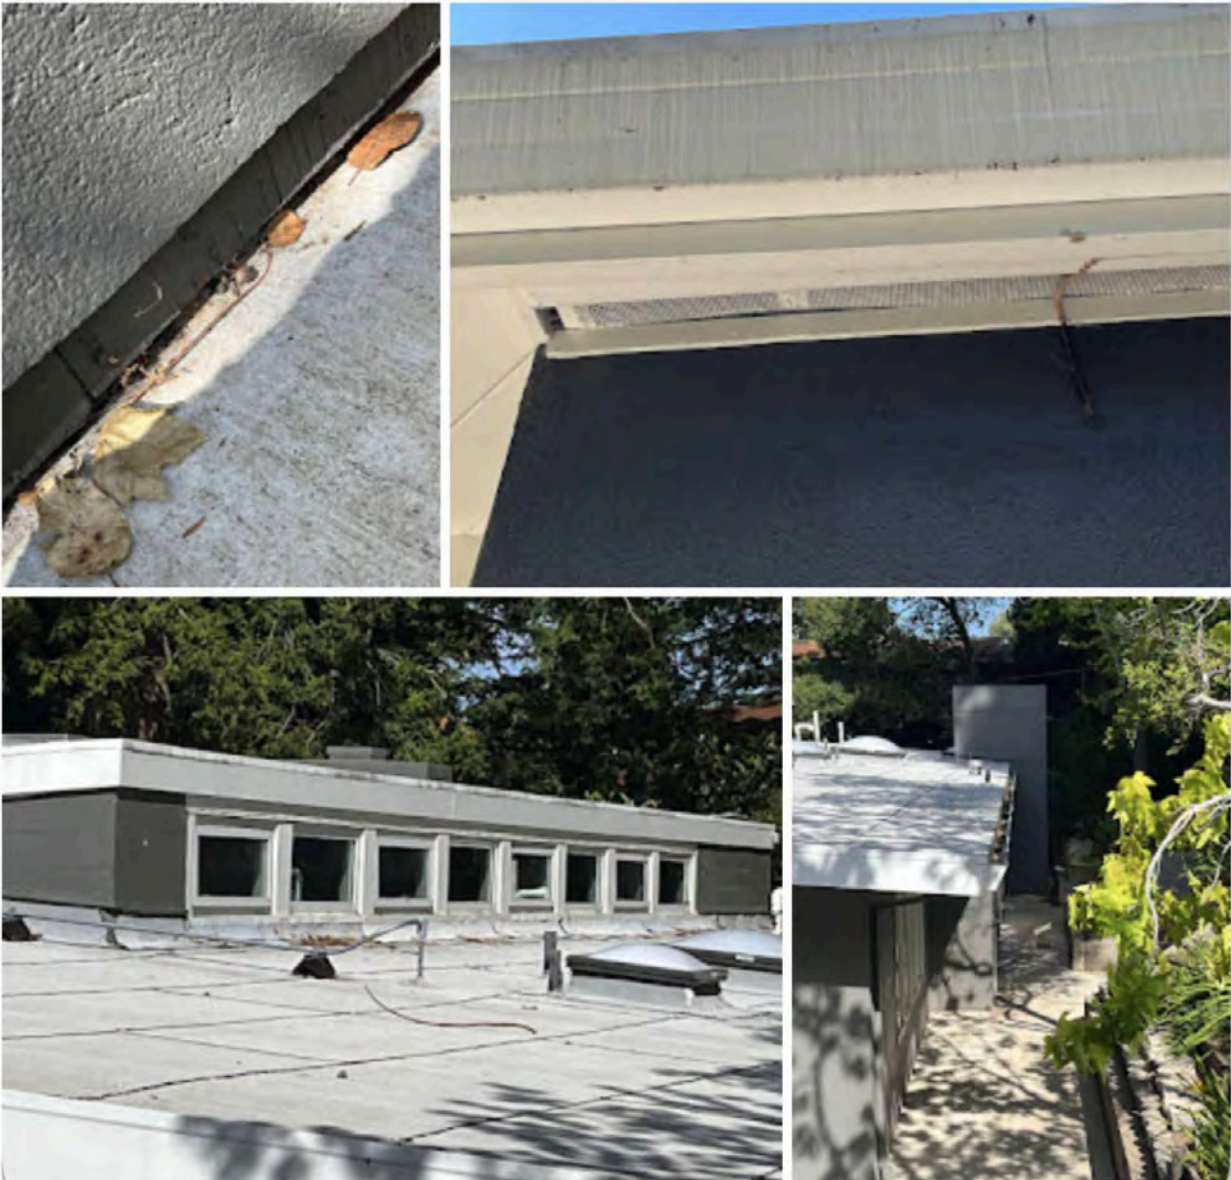
Also located at the roof level are domed skylights that appear to be acrylic. Acrylic can melt during a wildfire event, creating openings through which embers can enter the building. Similarly, clerestory windows at the roofline — some fixed, some awning-style — appear to be sitting improperly in their frames or slightly ajar, creating a potential pathway for ember intrusion.

A significant concern exists on the east side of the building, where the wall base lacks the recommended 6-inch noncombustible clearance from the ground. Old wood siding is visible below the stucco along portions of this wall, creating a combustible ignition point ranging from less than an inch to several inches above grade. This is a meaningful vulnerability: ember accumulation at the base of a wall is one of the most common ignition pathways during a wildfire.

Photos (clockwise from upper left): 6" combustible siding below stucco base, gap in soffit screen, clerestory windows, debris in gutters.

- If any clerestory windows are single-pane, consider upgrading to double-pane tempered glass to resist radiant heat and ember impact.
- When the acrylic skylights reach the end of their service life, replace them with low-profile skylights featuring multi-pane tempered glass and fitted with 1/8-inch mesh screens.

- Working with a licensed contractor, investigate the most cost-effective means of adding 6 vertical inches of noncombustible cladding wherever old wood siding is exposed below the stucco on the east wall. Suitable materials include metal flashing, fiber cement panels (such as Hardie Board), brick, stone, or stucco applied directly to the existing substrate.
- Fill any edge gaps on in the eaves or soffits with additional screening or intumescent fill to prevent ember infiltration.

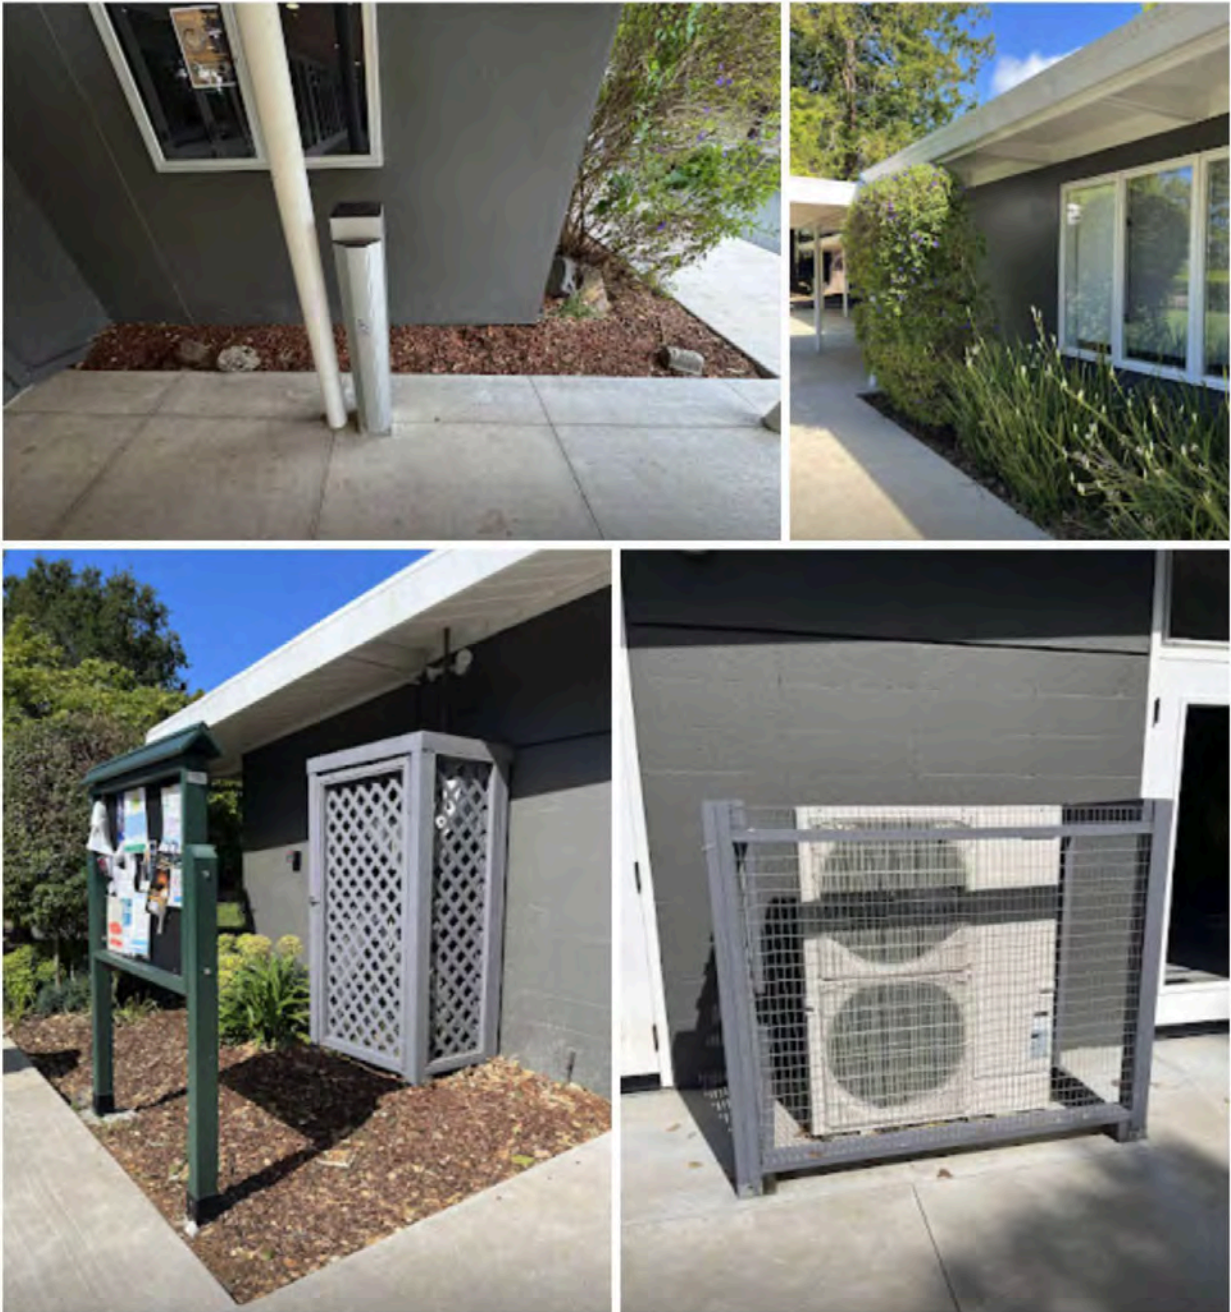
At the Community Center's main entrance and along the west side, an L-shaped planter cutout containing mulch and vegetation sits directly beneath the front overhang and eaves — a condition that will not meet the draft code. Rounding the south corner, additional landscape cutouts contain small trees, and two wood-slatted screens concealing mechanical equipment, which are located under the eaves, also noncompliant.

Photos (clockwise from upper left): L-shaped planter with mulch and vegetation beneath eaves at front; wooden screens for mechanical equipment on side.

- Replace the wood-slatted screens concealing the mechanical equipment on the south side with metal or other noncombustible alternatives, such as fiber-cement panels, that can be painted to match the building.

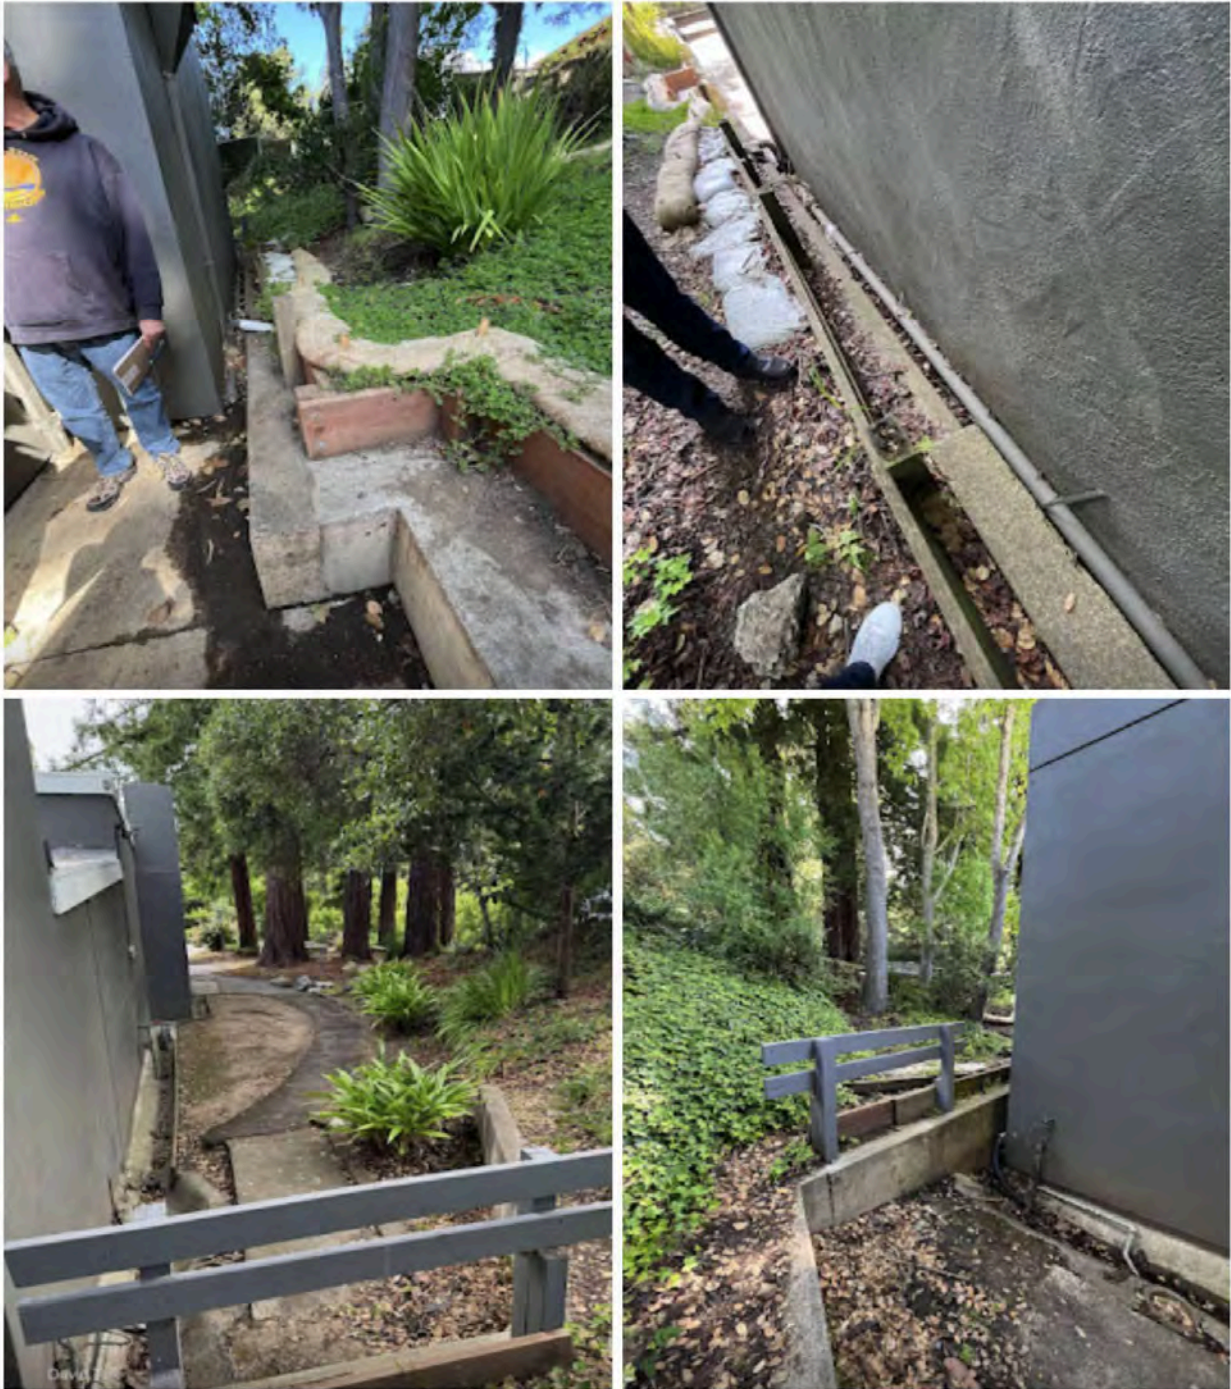
On the east side (rear) of the building, approximately 18 inches from the building perimeter, a water management system traps combustible organic debris beneath a drainpipe. Behind it sits a pressure-treated wood retaining wall, positioned directly behind a concrete retaining wall. The wooden wall shows signs of age — deteriorating posts, and the presence of sandbags and straw wattles suggests it no longer effectively manages hydrostatic pressure. The combination of trapped debris and a wooden retaining wall close to the building creates a meaningful ignition hazard. A combustible wooden barrier at the end of the east wall presents a further risk.

Photos (clockwise from upper left): Water management system and wooden retaining wall traps debris on the east side.

- Given the apparent age and declining effectiveness of the wooden retaining wall, consider replacing the entire rear drainage and retaining configuration with a more comprehensive system designed to manage both hydrostatic pressure and

wildfire risk. This is an opportunity to eliminate a combustible wall close to the building while improving drainage — a dual benefit.

- Replace the combustible wooden barrier at the end of the east wall with a noncombustible alternative, such as metal or fiber cement board.
- Limb all trees with branches within 10 feet of the roofline. While the draft regulations specify 5 feet, the 10-foot standard provides greater protection at minimal additional effort and is recommended. At the northeast corner, prune trees completely away from the roofline. Remove the understory bushes below the overhanging trees, or prune them to no more than one-third the height of the lowest tree limb, to eliminate the ladder fuel hazard.

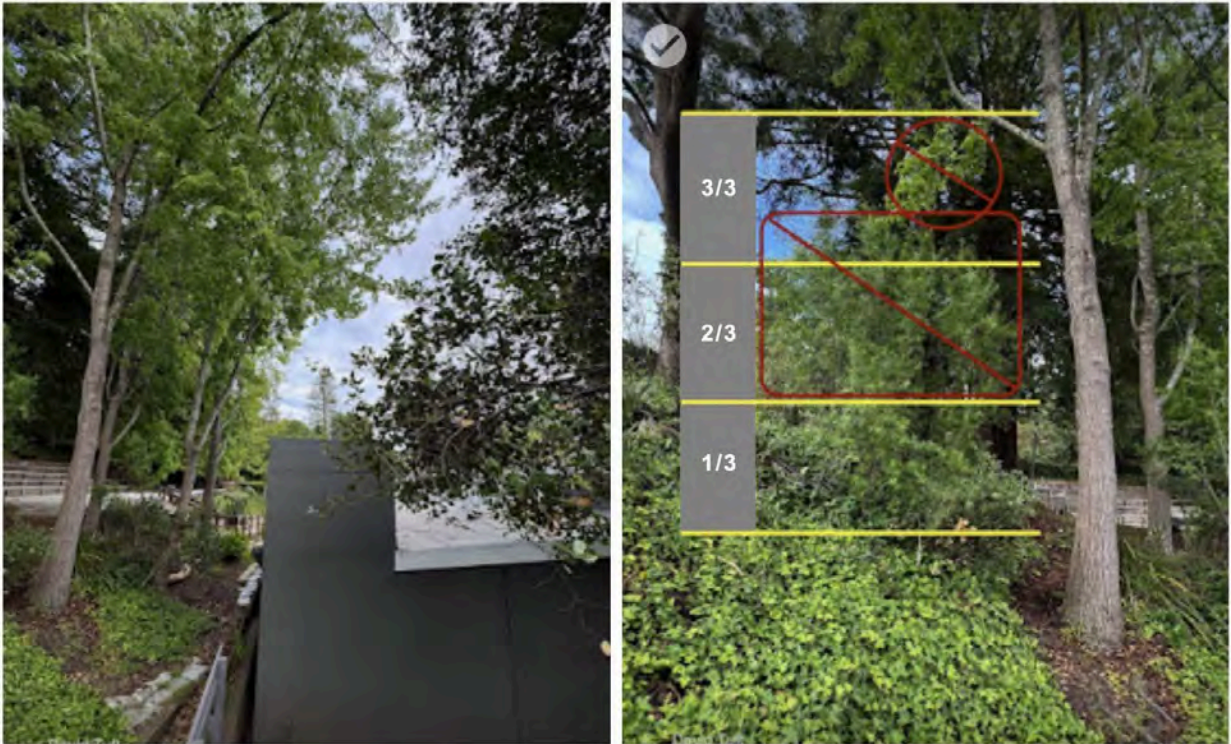
Photos: Tree overhanging the roof (L); ladder fuel understory at northeast corner showing where to cut limbs and underbrush (R).

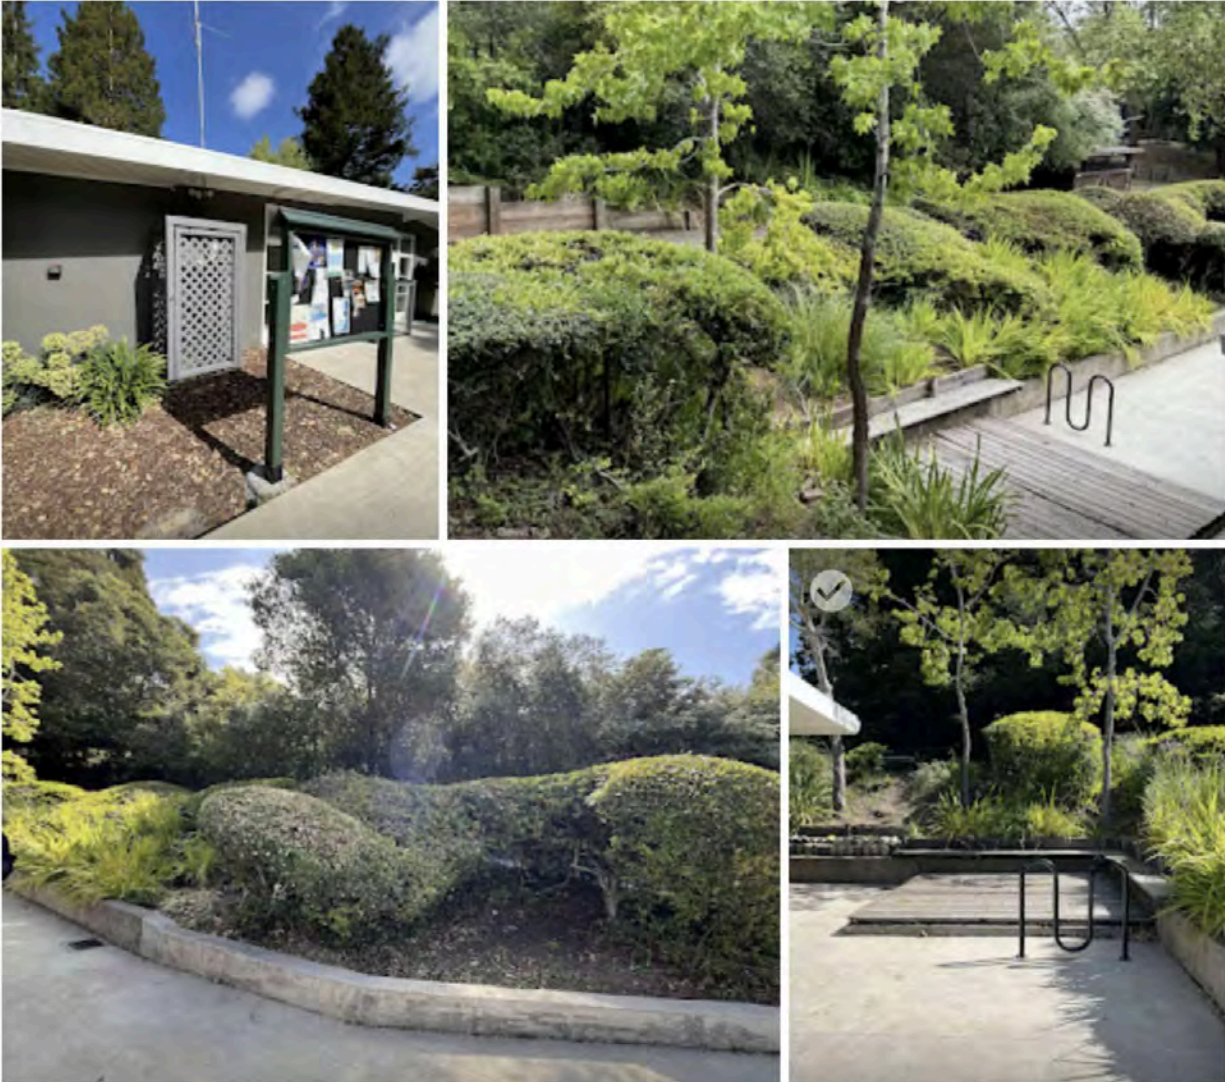
A Kirbybuilt message center made of recycled plastic is located in a planter cutout approximately 8 feet from the building's south perimeter. Recycled plastic is highly flammable. Moving the message board to the far side of the walkway — at least 10 feet from the building — and maintaining a 5-foot noncombustible zone around it would mitigate this hazard.

Photos (clockwise from upper left): Recycled plastic message board; wooden deck south of building. L-shaped planter with continuous vegetation on the south and east sides.

- Replace the wood decking at the southeast corner with a noncombustible material (concrete pavers, slate, stone tile, or similar). If replacement is not immediately feasible, consider its removal.
- Relocate the recycled plastic message board to a position at least 10 feet from the building. Ensure a 5-foot noncombustible zone is maintained around it at its new location.
- Redesign the L-shaped planter located behind the deck, to island vegetation into 10-foot clusters separated by 10-foot noncombustible breaks. Consult with a landscape architect experienced in fire-safe native plantings. Consider using this planter as a community demonstration garden for fire-resistant landscaping.

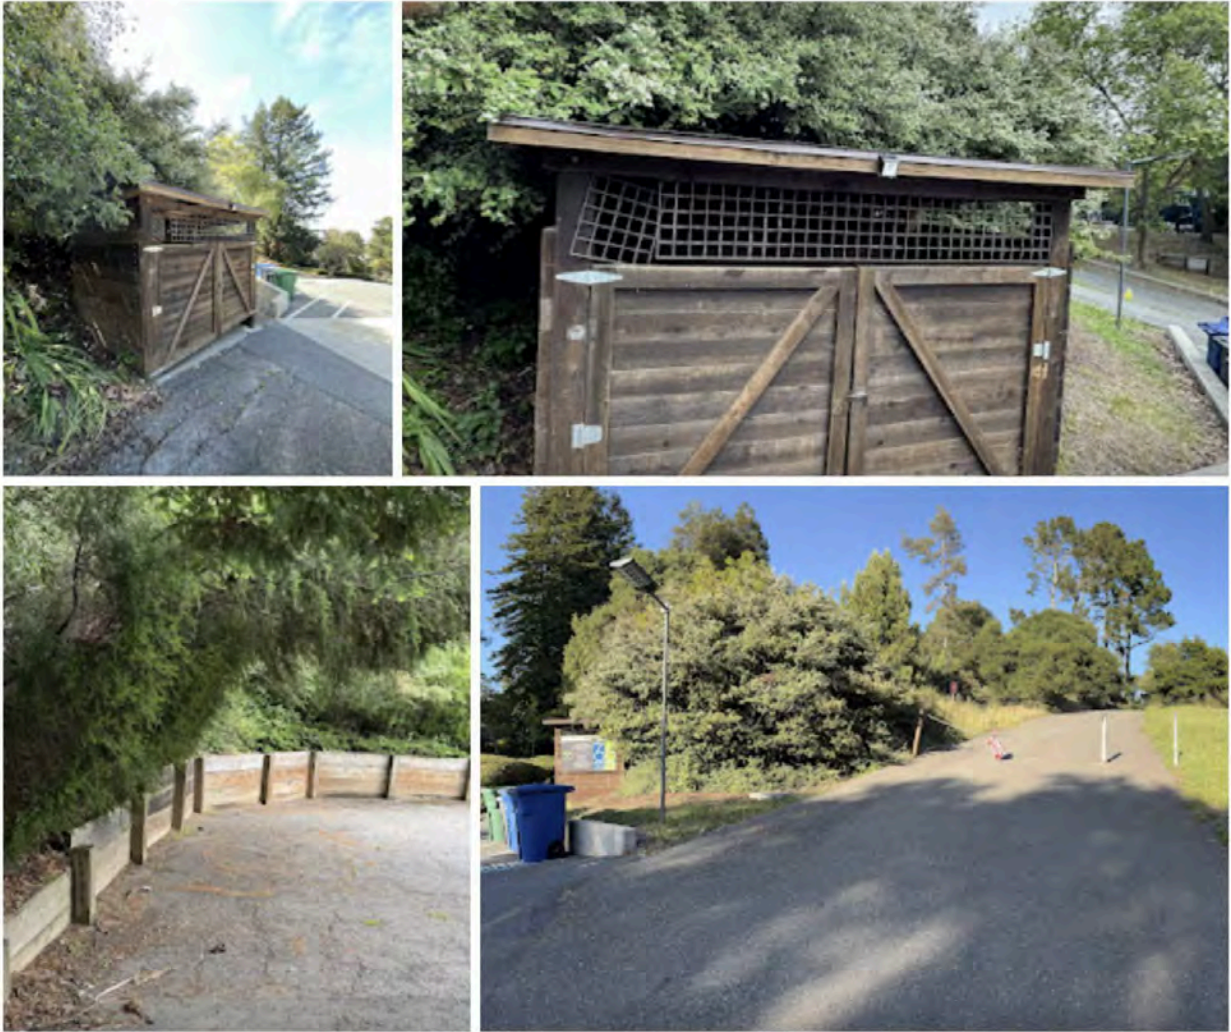
Photos (clockwise from upper left): Wooden garbage enclosure; surrounded by vegetation; vegetation between enclosure and Kensington Park Road; and dense vegetation along upper walkway.

- Conduct a comprehensive vegetation management assessment of the west side of the property, including the area between the garbage enclosure and upper pathway, and develop a thinning and spacing plan that meets current defensible space requirements, accounting for slope.
- Island the continuous hedge row west of the parking lot into 10-foot clusters with 10-foot noncombustible breaks, with particular attention to maintaining clear vehicle access and egress.
- Clear a minimum 10-foot perimeter of bare mineral soil around the wooden garbage enclosure.
- Ensure that the fire road/evacuation roadbed on the south side is kept clear of encroaching vegetation to maintain access for fire apparatus and evacuees.

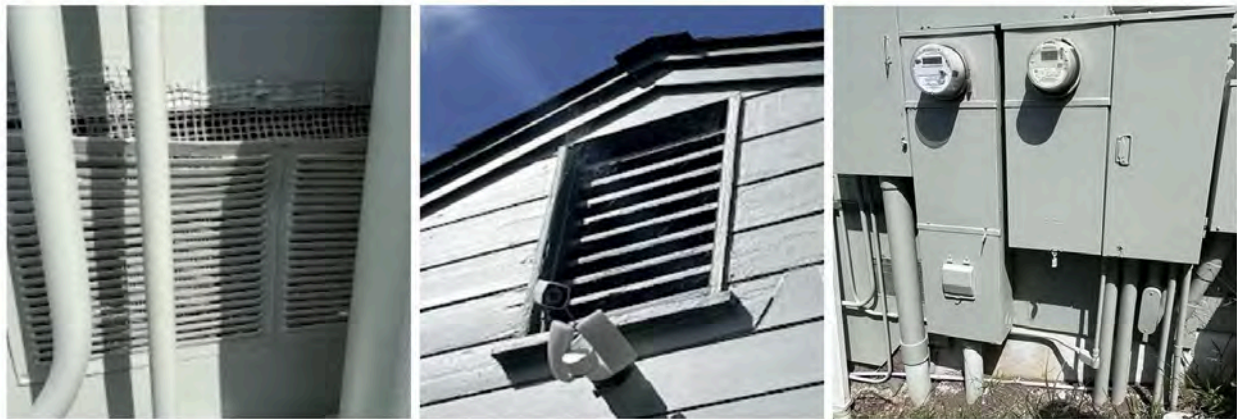
The Recreation Building's foundation and gable vents do not appear to have appropriately-sized ember-resistant mesh screening. Gaps and openings around electrical and other utility boxes attached to the south wall also present points of entry for embers.

Photos (from left): vents needing repair, and rodent mesh screen; gable vents requiring check for screen size; and gaps found around several wall penetrations.

- Retrofit all foundation and gable vents with 1/16-inch or 1/8-inch corrosion-resistant mesh screening. This is a high-priority, relatively low-cost action.
- Inspect all utility boxes and conduit penetrations on the south wall. Cover or enclose any gaps and openings with appropriate mesh or intumescent caulk to prevent ember accumulation and intrusion.

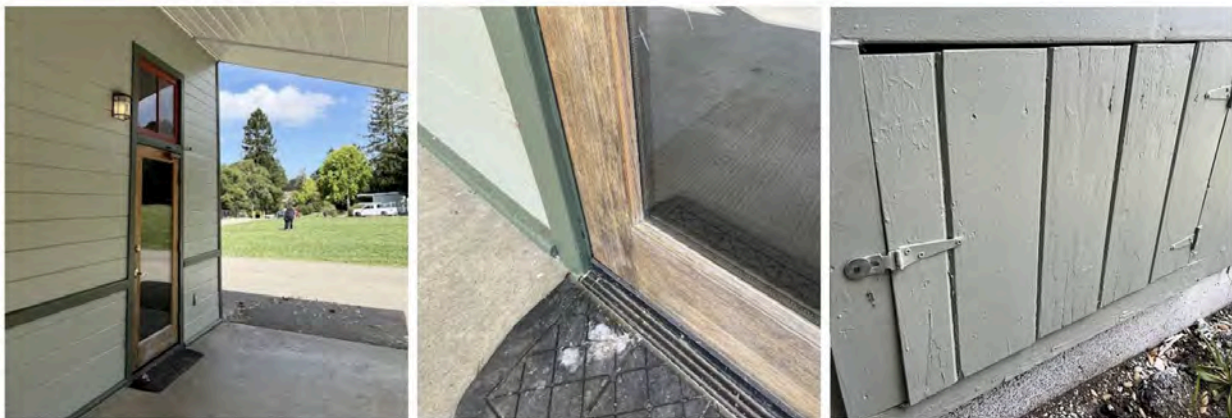
The concrete foundation along the west side of the Recreation Building provides an excellent 6-plus-inch clearance between siding and ground for most of its length, with the exception of an approximately 20-foot section where wood siding comes too close to grade. The exterior doors on the east side also warrant attention: the base of the doors and the siding beneath them should maintain similar noncombustible separation from the concrete walkway below.

The small wooden utility access door on the west side of the building is a separate concern. Wood doors and panels in exterior utility access points are an ignition hazard,

Photos (from left): Two views showing combustible wood at the base of doors and siding; and a wooden access door with a poor fit and ember entry gaps.

- Create a 6-inch noncombustible clearance at the base of the west wall. Expose the existing concrete or apply metal flashing or another noncombustible material along this 20-foot section of wall.
- Add noncombustible flashing or a 6-inch noncombustible base treatment along the bottom of the siding and doors on the east side to create proper separation from the concrete walkway. This can be painted to match the building's color.
- Replace the small wooden utility access door on the west side with a noncombustible alternative — such as fiber cement board (Hardie Board) or other noncombustible material — and ensure it is fitted to close and latch securely.
- During Red Flag events, remove all door mats from building entrances, and move any potted plants to a location at least 5 feet from the building and doorways.

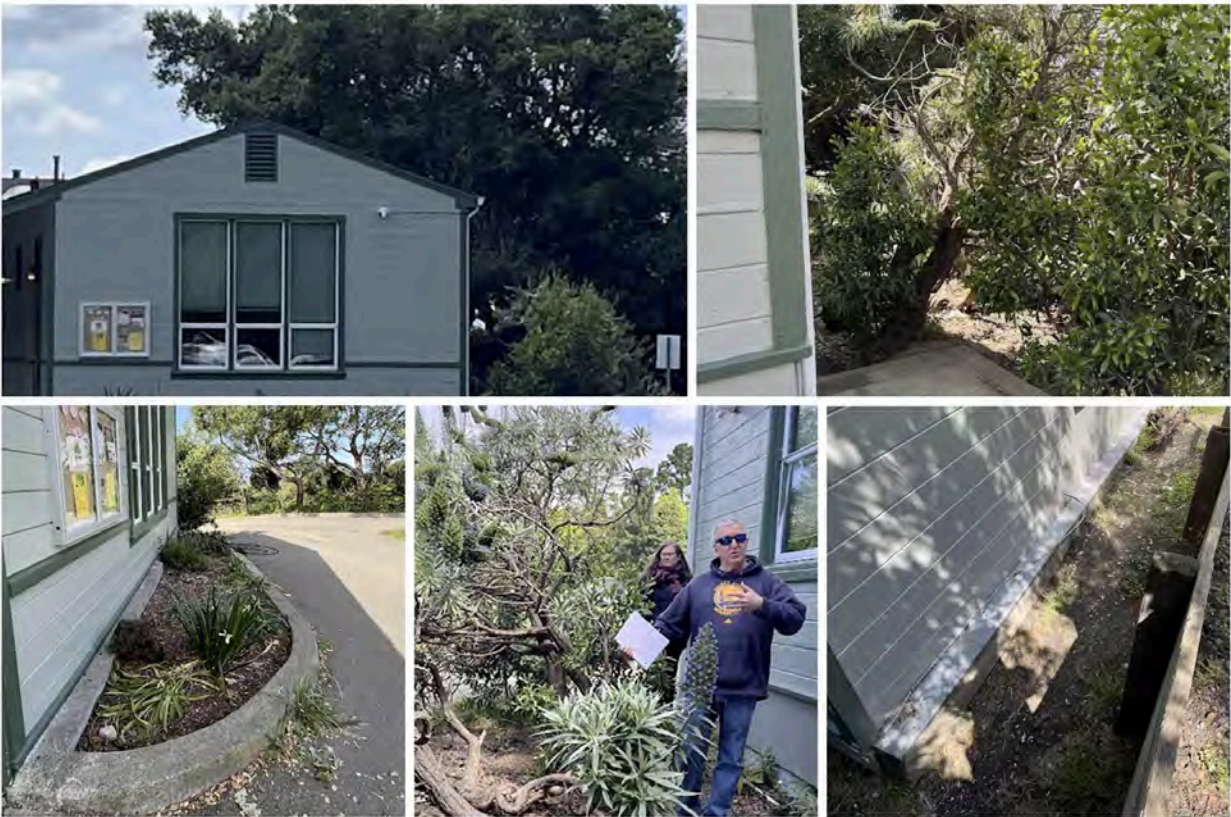
The north side of the Recreation Building has a planting area beneath a window that currently contains vegetation. Under both current best practice and the forthcoming Zone 0 regulations, vegetation within 5 feet of the building — and particularly beneath windows and eaves — must be removed and replaced with noncombustible material. Embers landing in a planted area close to a window can smolder and eventually ignite the building.

On the south side and southwest corner, vegetation management within 5 feet of the building is also needed: weeds, ground cover, and plant material in this zone should be removed and replaced with gravel, rock, or another noncombustible surface. The wooden retaining wall near the southeast corner is another concern; combustible retaining walls near a structure can contribute to building ignition. This creates a narrow corridor between the buildings that can trap debris.

Photos (clockwise from upper left): view of trees and vegetation overhanging structure; vegetation in Zone 0 on NW corner; planter under north-side windows; overgrown vegetation on NW corner; wooden retaining wall in southeast corner prone to collecting debris.

- Remove all vegetation from the planting area beneath the north-side window. Replace with gravel, rock, or another approved noncombustible material.
- Remove the overgrown vegetation and plant material at the northwest corner of the building.
- Apply gravel, rock, or other noncombustible material within 5 feet of the west side of the building, beneath the oaks, to reduce debris accumulation and ember risk.
- Remove all weeds, groundcover, and combustible debris along the south wall and within 5 feet of the building on the south and west sides. Apply gravel, rock, or other noncombustible ground cover throughout this area.
- Keep the ground between the retaining wall on the east and south side of the building free of all vegetation and debris. When it reaches the end of its useful life, replace with a noncombustible alternative — concrete block or a noncombustible material.

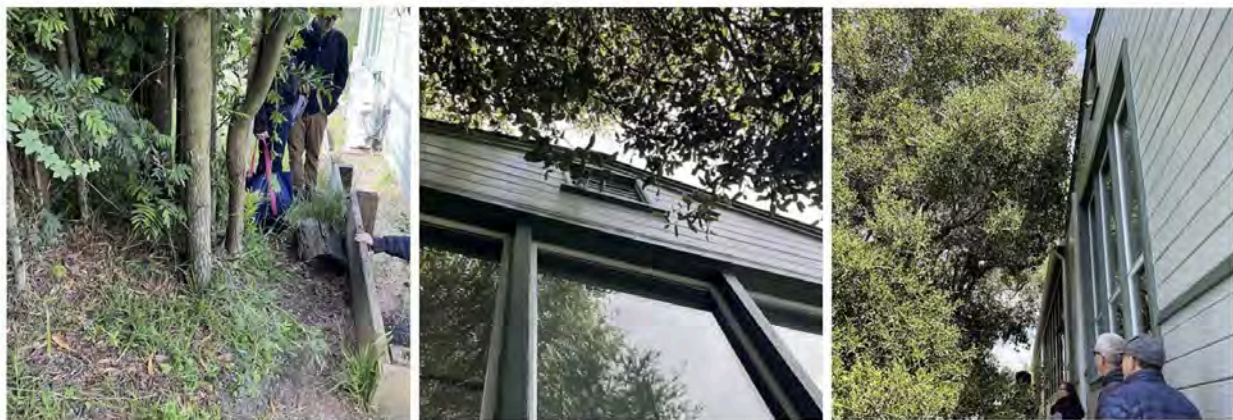
Photos (from left): cluster of trees crowding the building at southeast corner; two views of the large oak trees on west side touching the roof and gable vent, and shedding leaves and branches.

- Remove the small cluster of trees at the southeast corner of the building, or, if total removal is not feasible, commit to partial removal and/or regular trimming to maintain at least 5 feet of clearance from the building and roof at all times. [addressed in May, 2026]
- Engage a certified arborist to develop a pruning plan for the large oak trees on the west side, achieving a minimum 5-foot setback from the roof edge. [addressed in May, 2026]
- Remove all leaf litter, vegetation, and debris from beneath the oaks and maintain regularly.
- Prune and thin the vegetation on the south and southwest hillside to achieve the spacing requirements described in the Appendix, accounting for slope. Remove all weeds and debris regularly.

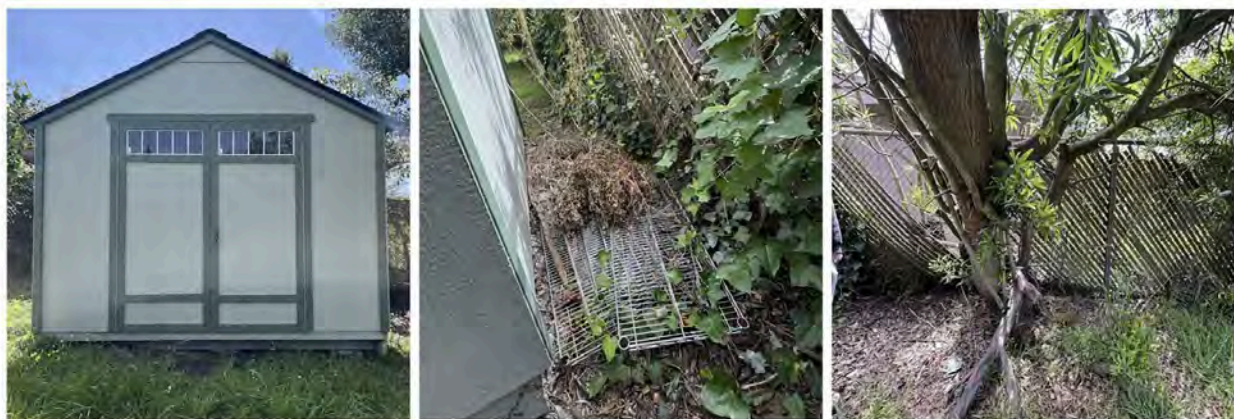
A small storage shed to the east of the Recreation Building is classified as a detached structure and has its own defensible space requirements. The shed's current condition — surrounded by weeds and debris, with an open base that may provide access for rodents and combustible material — requires attention. Coordination with the adjacent neighbor regarding the shared cyclone fence and overhanging trees is also warranted.

Photos (from left): underside of shed open, weeds and debris between shed and fence; and wooden slats on cyclone fence showing areas in need of repair.

- Clear all weeds and debris from around the shed. Establish a 5-foot zone of noncombustible material — gravel or rock — around the entire structure.
- Attach fire-resistant mesh to the base of the shed and bury it at least 6 inches into the ground to prevent animals from burrowing beneath the structure and accumulating nesting material.
- Coordinate with the adjacent neighbor to trim back trees and vegetation that overhang or encroach on the shed, and to repair the shared cyclone fence. Remove any wooden slats from the cyclone fence; if privacy screening is needed, replace with aluminum slats.

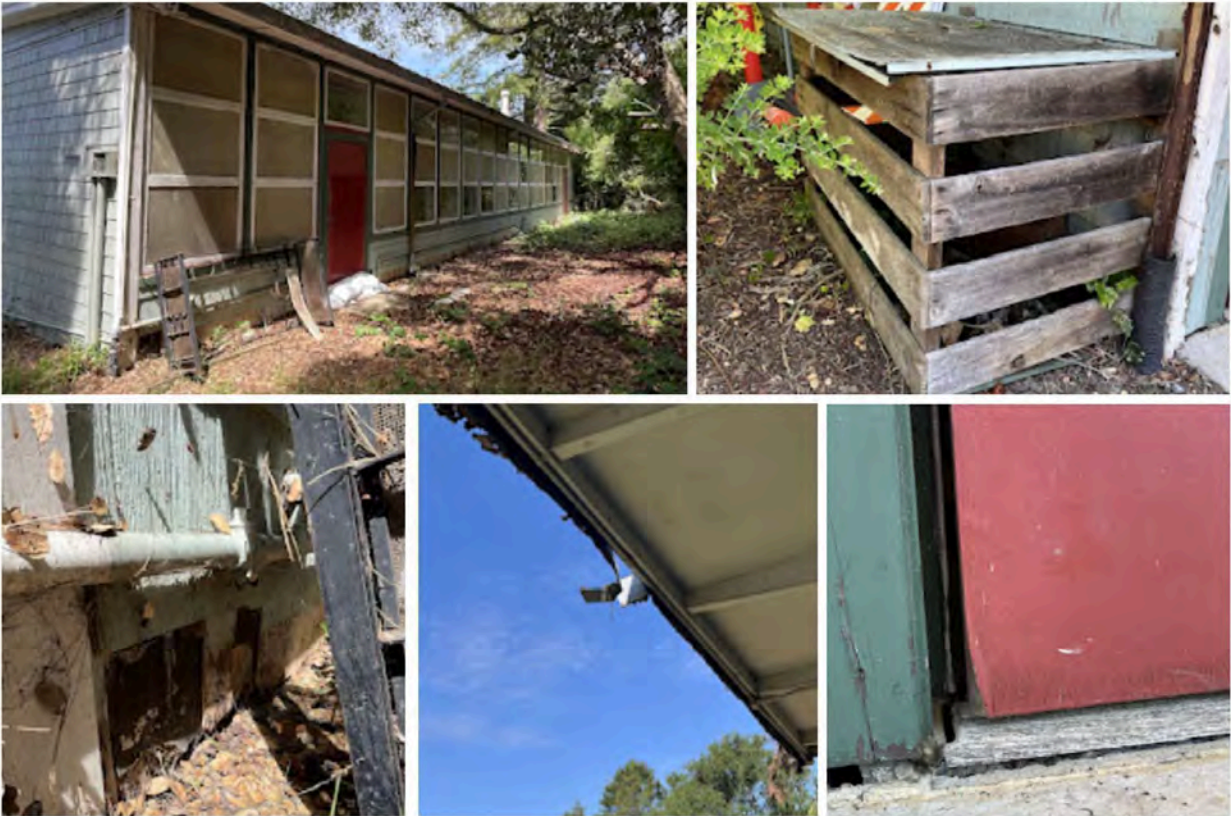
The Annex exhibits multiple significant points of vulnerability to ember intrusion and structural ignition. Based on exterior visual inspection, affected elements include the siding, windows, doors, gutters, and likely the roof assembly. The building shows visible signs of deterioration across much of its exterior.

It is the assessment team's judgment that a majority of the structure's exterior — estimated at 60 to 80 percent — would require upgrade or replacement to achieve meaningful fire resistance. This is not a building that can be hardened with targeted,

low-cost improvements. Any serious effort to bring the Annex into compliance with current fire safety standards would constitute a substantial renovation.

Photos: View of building from rear showing worn siding, missing windows, and multiple areas of decay.

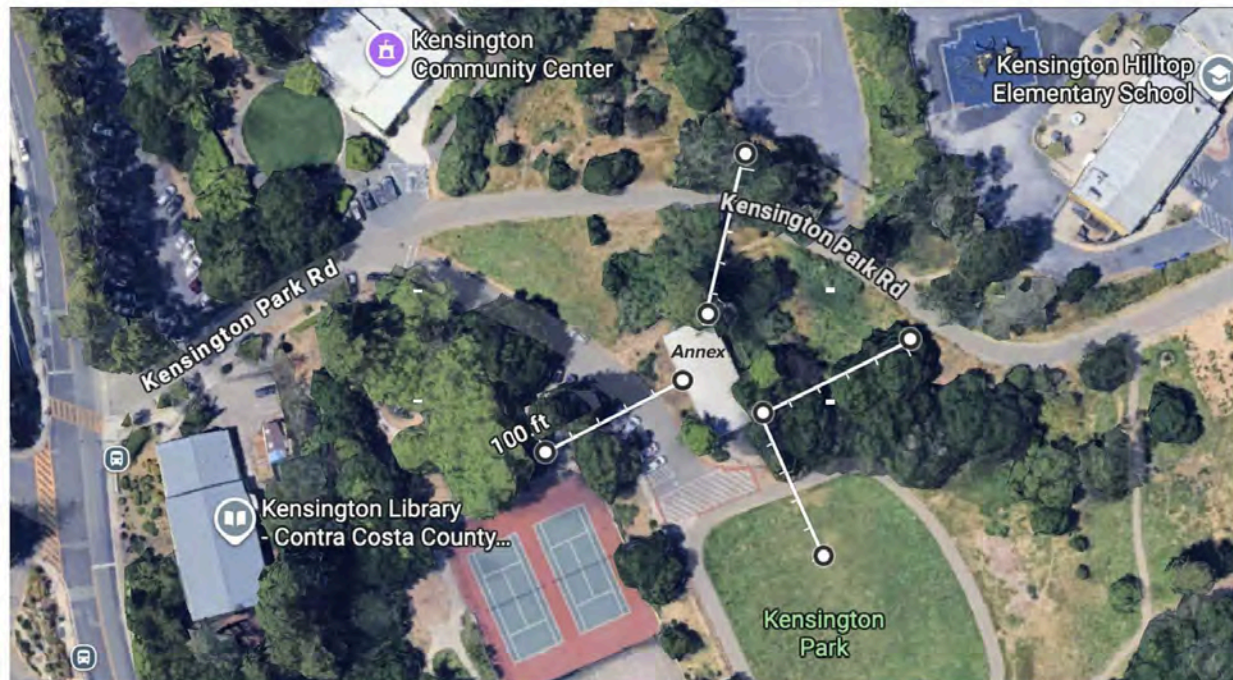
Of particular concern is the building's relationship to Kensington Park Road, which runs upslope and in close proximity. This road serves as a popular pedestrian path, a fire access route, and a potential evacuation corridor for schoolchildren and Tilden Park hikers descending toward Arlington Avenue. Due to the combination of slope, current vegetation density, and the building's condition, a fire involving the Annex and its surrounding vegetation could produce enough radiant heat and ember output to compromise the safety of this evacuation route.

The trail with railroad-tie steps adjacent to the Annex is a potential evacuation route with fire risk from vegetation and the combustibility of the Annex itself. It should be evaluated for fuel reduction management as part of a comprehensive evacuation route analysis.

Photo: Aerial view of Annex building with 100' defensible space zone marked in white. Note the parking lot, tennis courts and picnic area to its west. Kensington Park Road walking path is upslope, winding around the building. The foot trail just north of the building cuts through the vegetation to the picnic area.

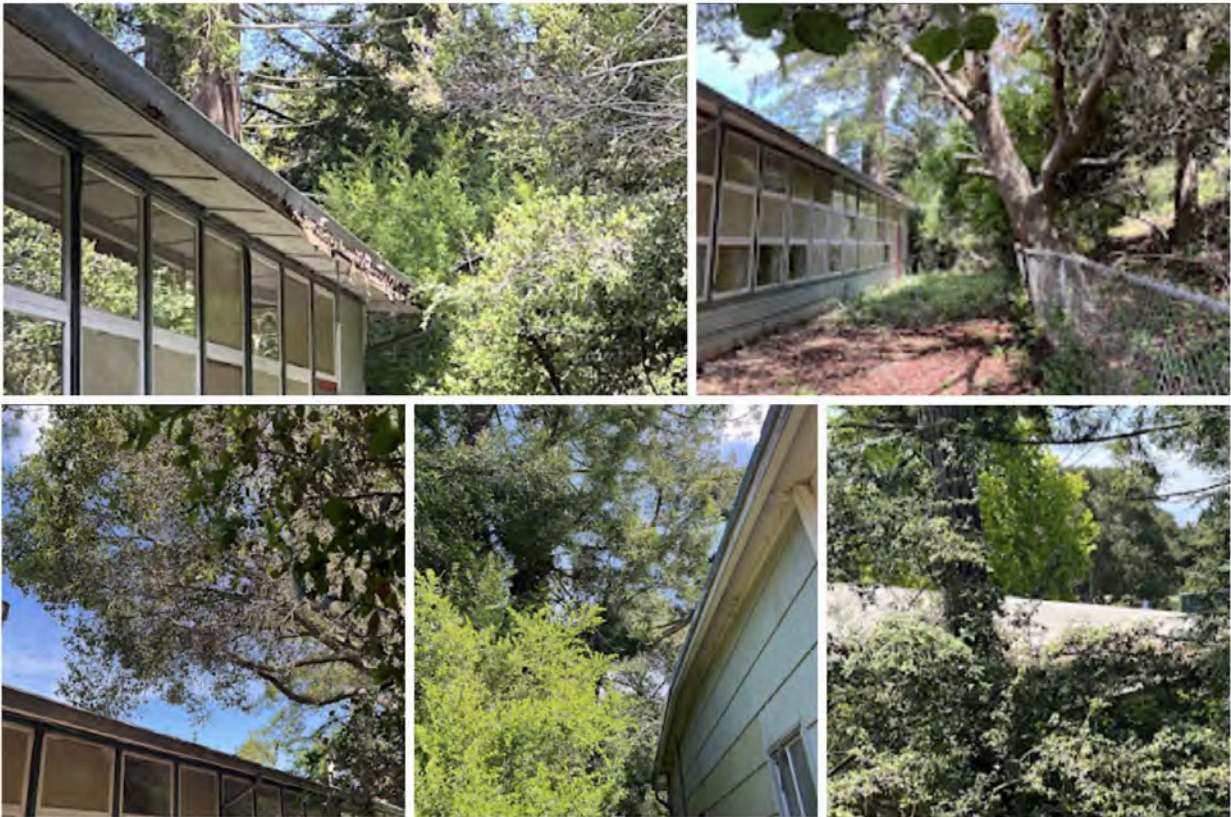
The vegetation surrounding the Annex is dense, aged, and in several areas highly combustible. Ladder fuels — shrubs and understory vegetation that allow ground fire to climb into the tree canopy — are present. The area between the building and Kensington Park Road is of particular concern, given the uphill fire behavior that slope conditions promote and the proximity to the evacuation corridor.

Current conditions do not meet recommended defensible space practices for any of the three zones. While the building's structural condition is the primary driver of the overall risk level, the vegetation surrounding it can and should be addressed immediately, independent of any decision about the building itself.

Photos: Views of dense vegetation between rear of building and Kensington Park Road, ladder fuels, and tree limbs overhanging the building.

- Remove all combustible materials attached to the building. This includes benches, wood add-ons, and enclosures. Replace with noncombustible alternatives where needed.
- Given the building's poor structural condition, consider expanding the noncombustible buffer around the building to 10 feet rather than the standard 5, to provide additional margin.
- Thin dense shrubs, ladder fuels, and understory vegetation throughout Zones 1 and 2, following the CAL FIRE vegetation management guidelines described in the Appendix and accounting for slope conditions.

- Treat the area between the building and Kensington Park Road as a priority corridor: clear vegetation to the maximum extent possible consistent with slope stability, and ensure the evacuation route remains passable and free of overhanging fuel.
- Replace or redirect the railroad-tie trail through this area with a wider, fire-resistant footpath — compacted gravel or decomposed granite — and formally designate this corridor as a secondary evacuation route.
- Update the park's vegetation management standards and maintenance schedule to address this area explicitly, with attention to preventing rapid regrowth and the spread of invasive species.

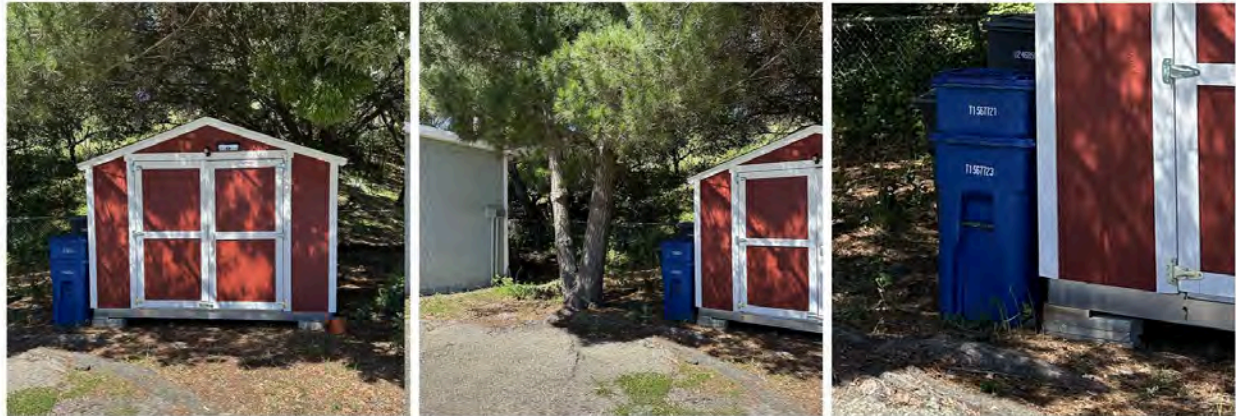
Photos (from left): View of new shed, proximity to annex and tree with overhanging branches; and combustibles, debris and open base under the structure.

- Prune back tree limbs overhanging the shed, allowing for a minimum 5-foot clearance from the roof.
- Remove all combustible items within 5 feet of the building.
