Wildfire Risk Assessment

Kensington Park Structures

Kensington, California

Report Date: May 18, 2026

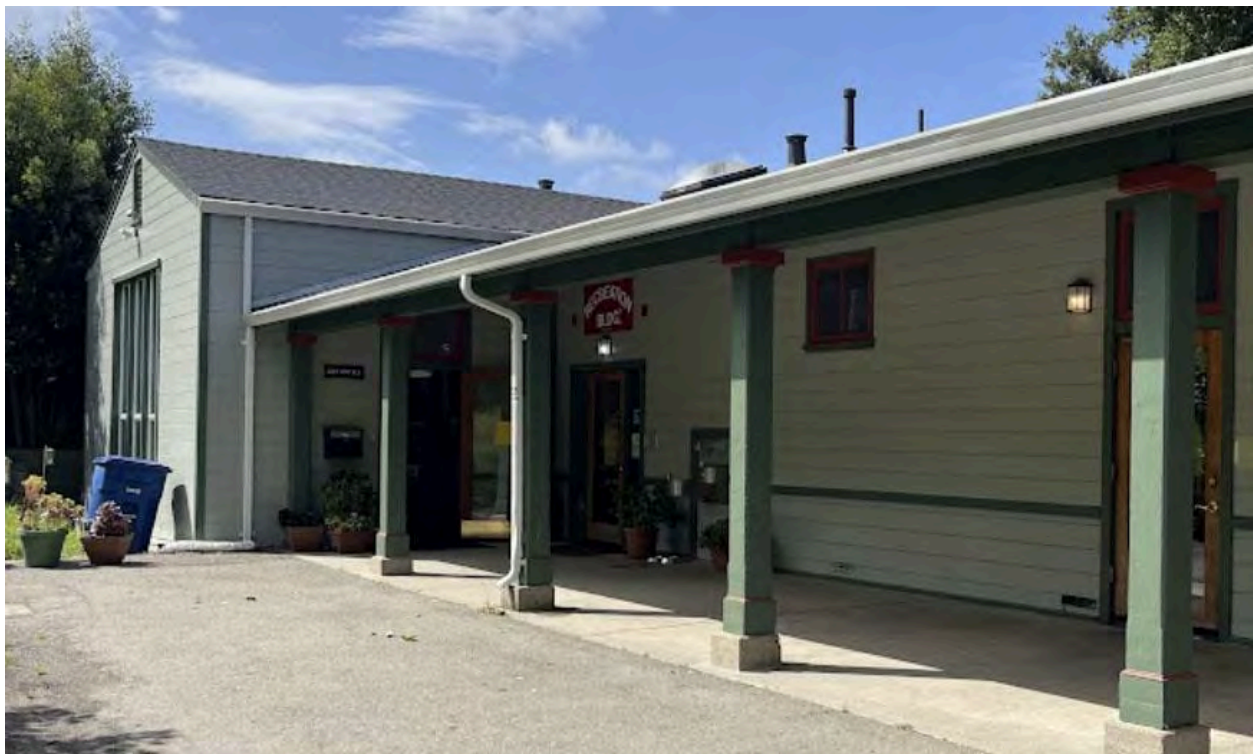
The Recreation Building's foundation and gable vents do not appear to have appropriately-sized ember-resistant mesh screening. Gaps and openings around electrical and other utility boxes attached to the south wall also present points of entry for embers.

Photos (from left): vents needing repair, and rodent mesh screen; gable vents requiring check for screen size; and gaps found around several wall penetrations.

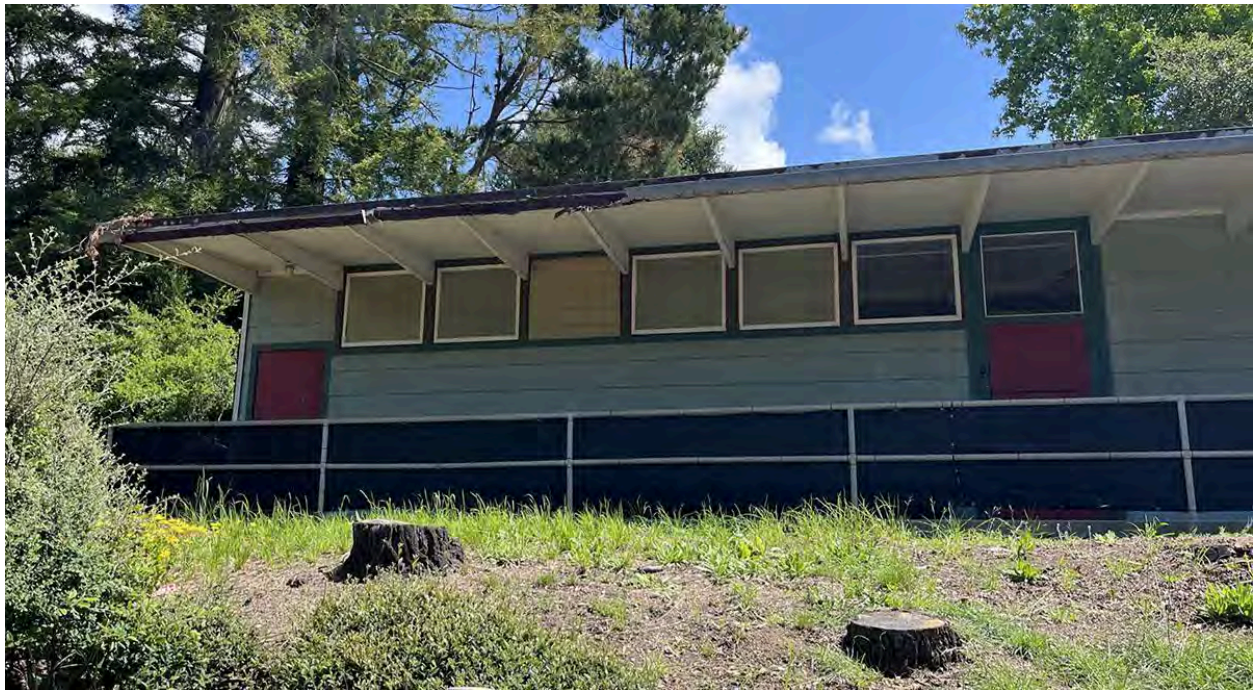
The Annex exhibits multiple significant points of vulnerability to ember intrusion and structural ignition. Based on exterior visual inspection, affected elements include the siding, windows, doors, gutters, and likely the roof assembly. The building shows visible signs of deterioration across much of its exterior.
